Double dipping Process

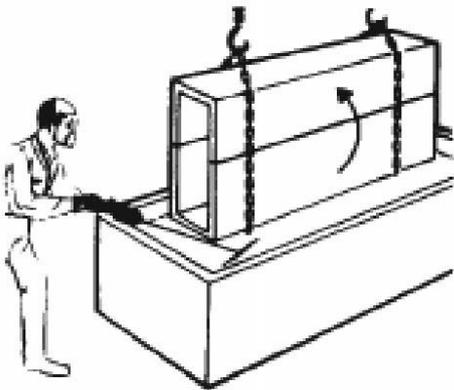
Double-end dipping for excess depth

Double end or depth dipping is a term used to describe the process of galvanizing an item which is longer or deeper than available bath dimensions. In this procedure the item is lowered into the bath so that half or more of its length or depth is immersed in the zinc bath. When the zinc coating has been achieved, the item is raised from the bath and adjusted in handling so that the ungalvanized part can be immersed in the bath. It should be noted that in this procedure an overlap of zinc coating will occur and this may have to be addressed in the case of visually obvious structural elements that require an aesthetic finish.

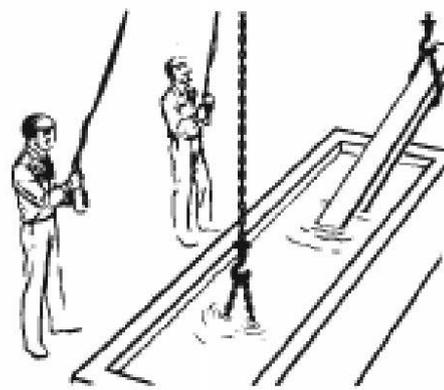
Double-end dipping for excess length

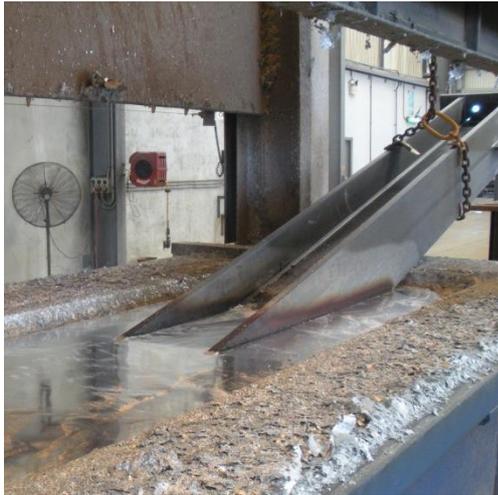
Photo 1

Photos 1 and 2 show the first stage, where one end is being immersed in the molten zinc while the excess length remains bare steel. After an article is removed from the zinc, at this stage it may or may not be quenched. This decision may be influenced by various factors, including the risk of distortion.

The five photos below show an example of a beam too long for the zinc bath which was double dipped.

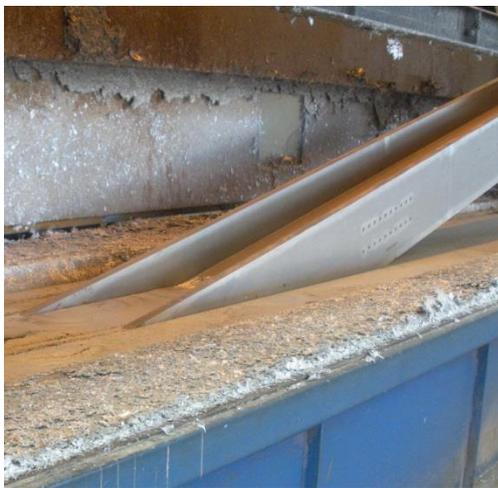
Photo 3 shows the part of the beam that wasn't galvanized (in Photos 1 and 2) immersed in the molten zinc. Photo 4 shows a distinct difference in appearance between the parts of the beam galvanized at different times as the beam is being withdrawn from the molten zinc for the second time.

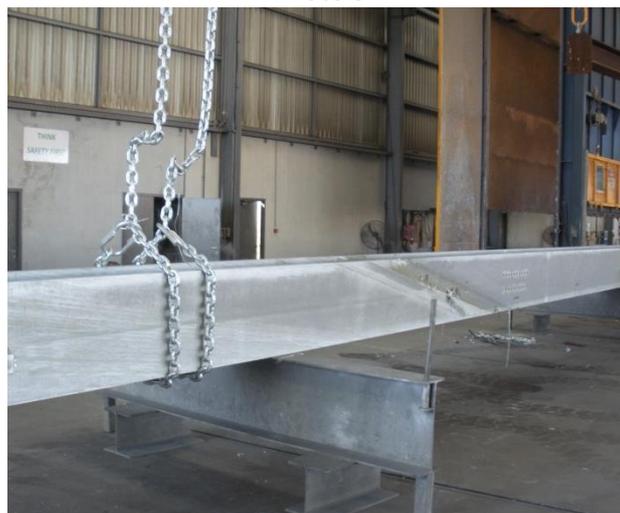
Photo 5 shows the whole beam after both ends were galvanized. The appearance of the galvanized coating on the right side of the 'double dip line' is duller due to the fact that it was galvanized first and, mostly likely due to slow cooling, the zinc-iron alloy layers of the galvanized coating have continued to form and consumed much of the zinc which was on the surface upon withdraw from the zinc bath before it solidified.
